Torpedo Plant Dock and Piers:

Technical Analysis and Design Recommendations

City of Alexandria, Virginia

July, 1979

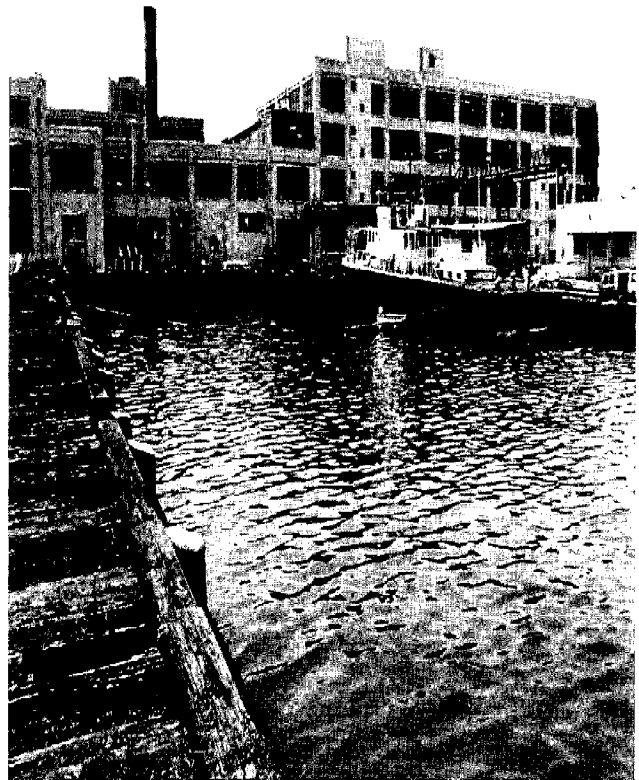
Figure 11 View of Buildings 2 and 3 from the South Pier

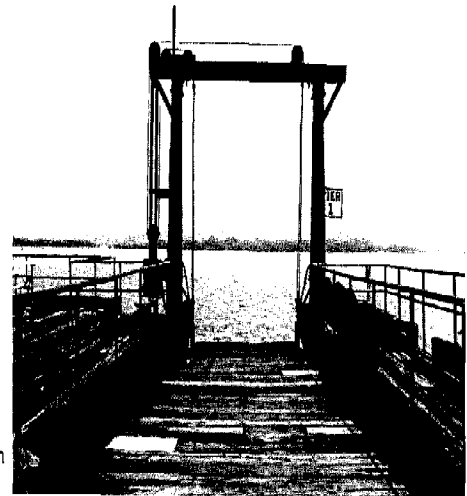
- **The North Pier is in generally good condition.**
 - The concrete portion which extends to the bulkhead line is in good condition.
 - The timber piles which support the wood pier between the bulkhead line and the pierhead line are good—31 percent showed decay of outer fibers only.
 - The internal bracing of the timber structure is in good condition.
 - 80 percent of the fender piles are deteriorated and need to be replaced.

Figure 14 Pulley system on North Pier
